HANDBOOK

6170.1

ELECTRONIC EQUIPMENT MODIFICATIONS HANDBOOK - DATA HANDLING EQUIPMENT

DEPARTMENT OF TRANSPORTATION
FEDERAL AVIATION ADMINISTRATION

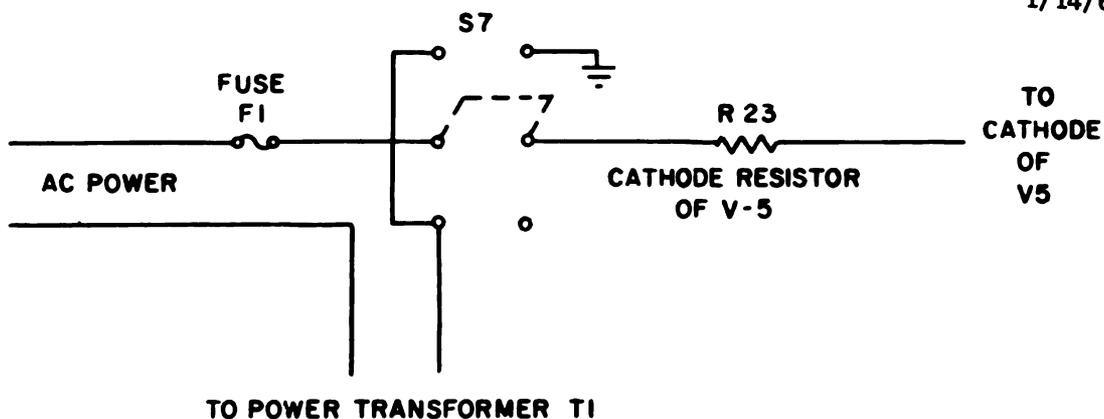
SWITCH WIRING AS SEEN FROM REAR OF SWITCH.
S7 - J-B-T INSTRUMENTS, INC. TYPE ST52P OR EQUAL.
LIMITED SPACE FOR SWITCH INSTALLATION.

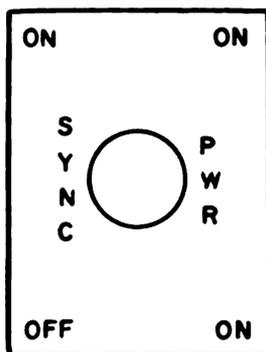
ESCUTCHEON PLATE FOR INSTALLATION
ON FRONT PANEL OVER POWER SWITCH

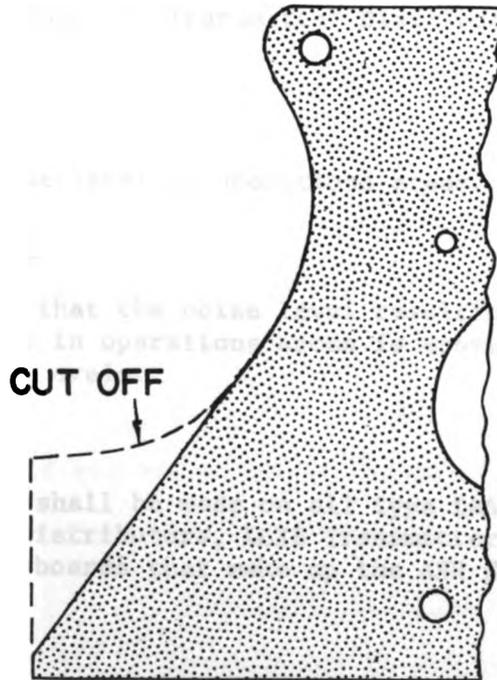
LEFT SIDE
TP-152538
FRONT PLATE

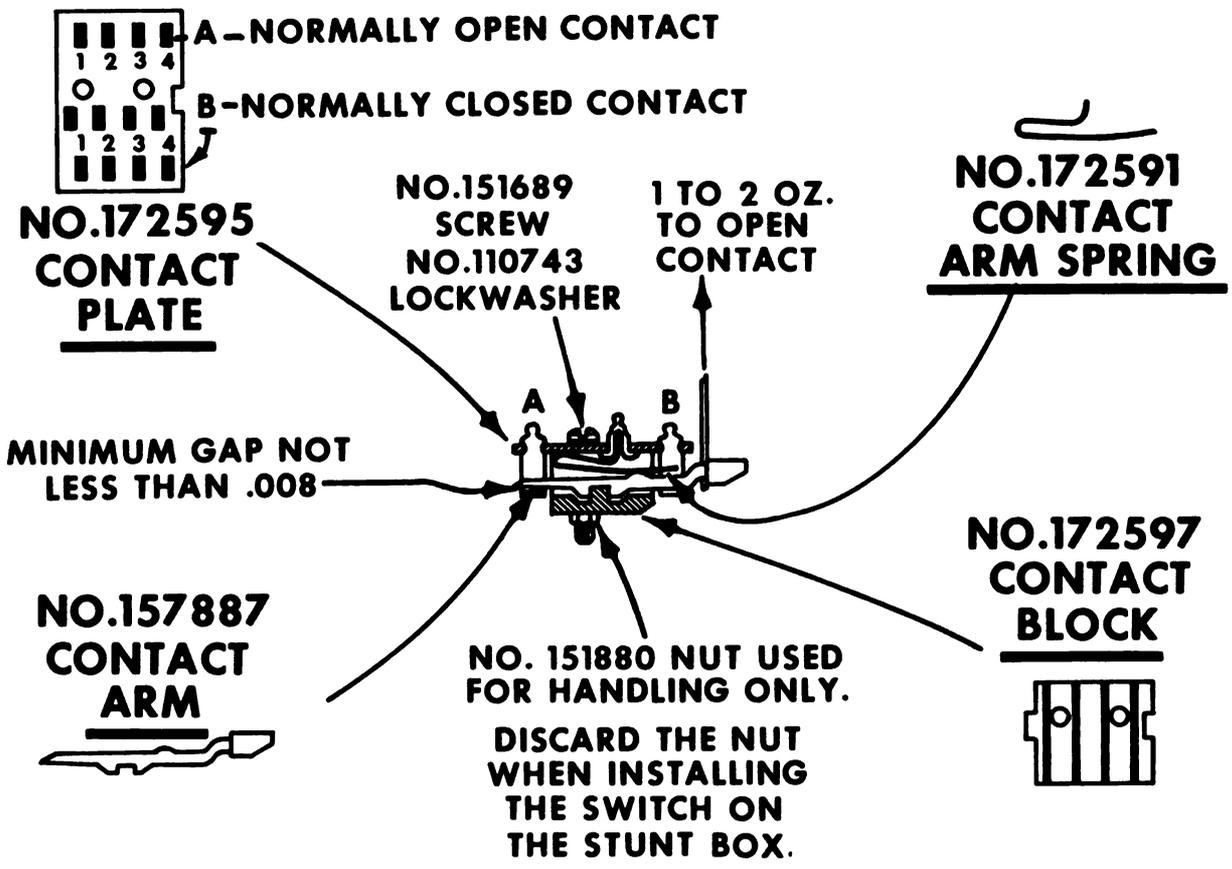
Sketch No. SK-B-135-4,
6-28-60

NO.172525 SWITCH ASSEMBLY FUNCTION BOX

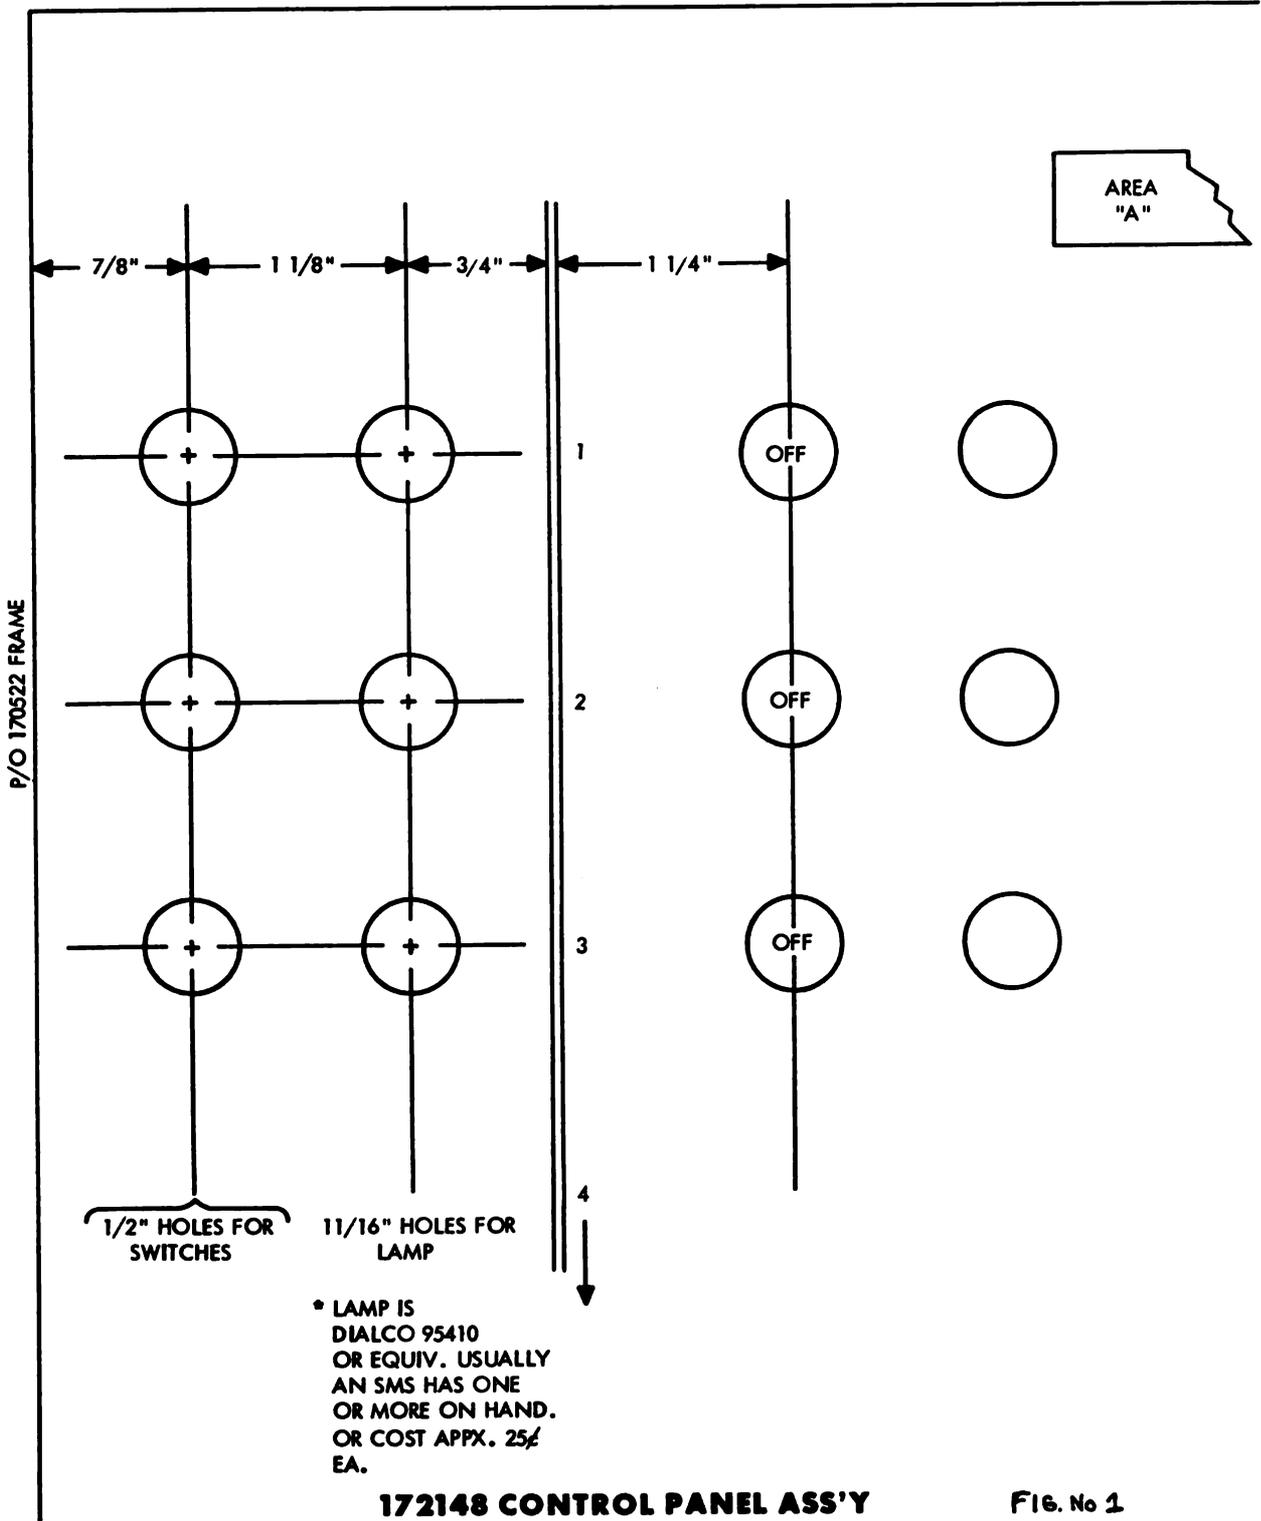
FIG. No 1

172148 CONTROL PANEL ASS'Y

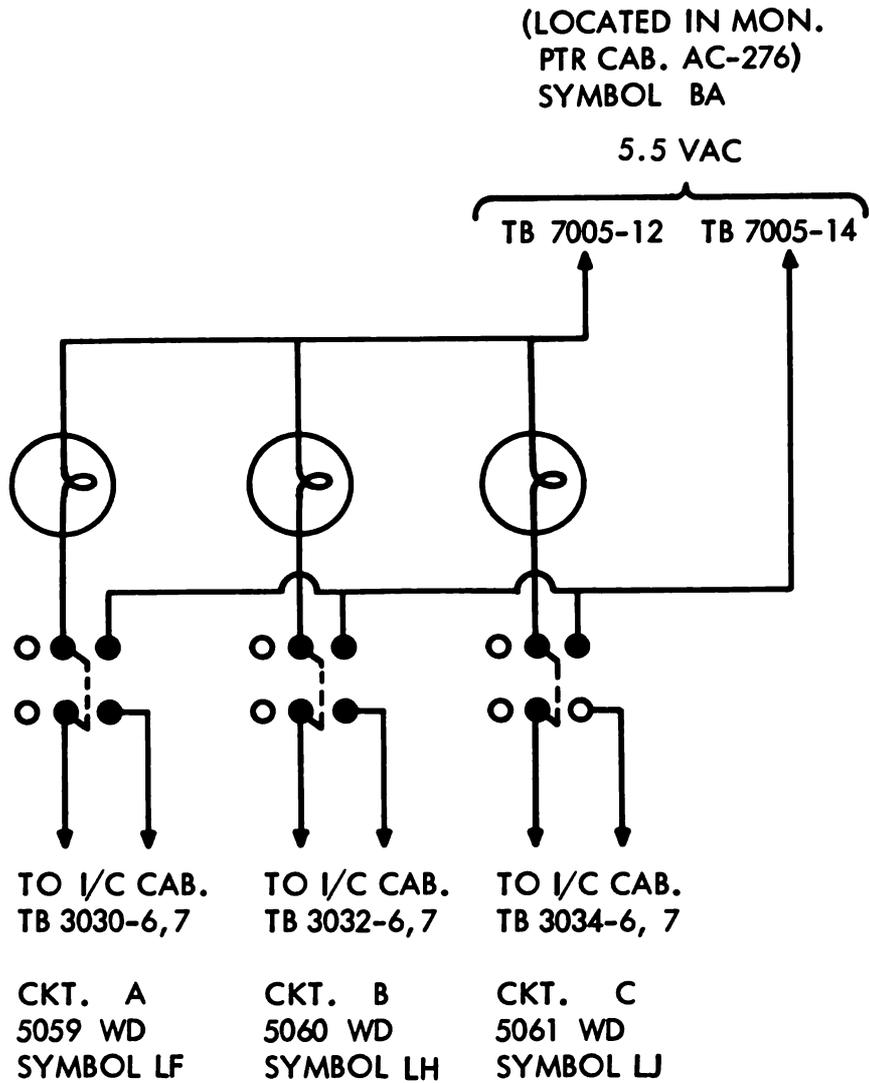
FIG.No2

**ADIS - CONTROL OF AREA CIRCUIT
TRANSMISSION**

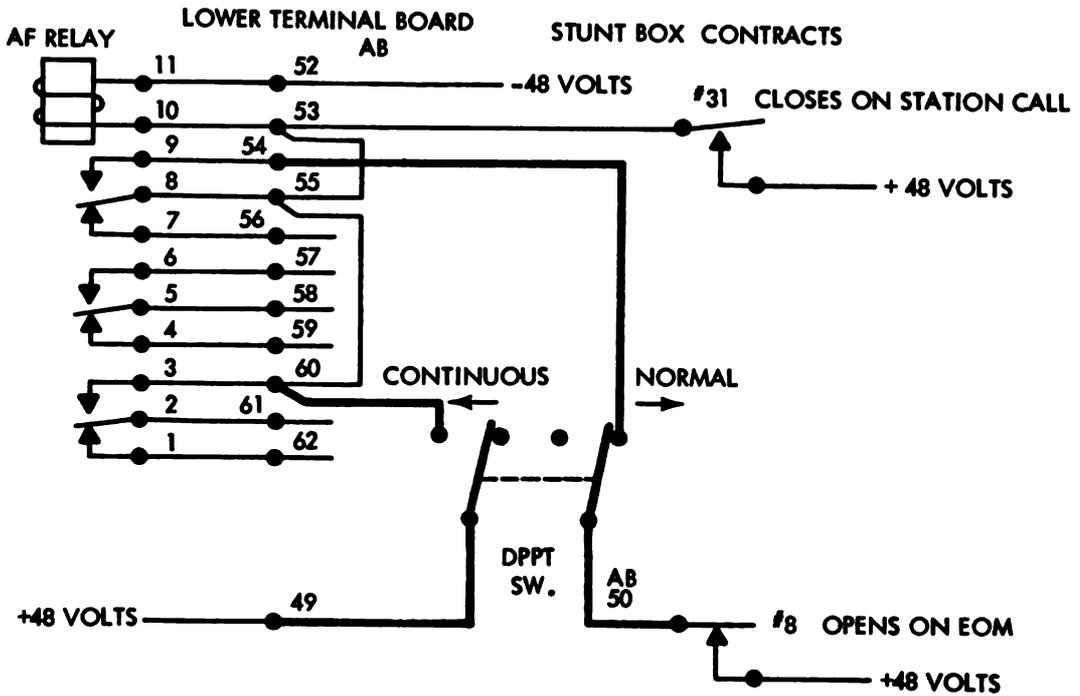
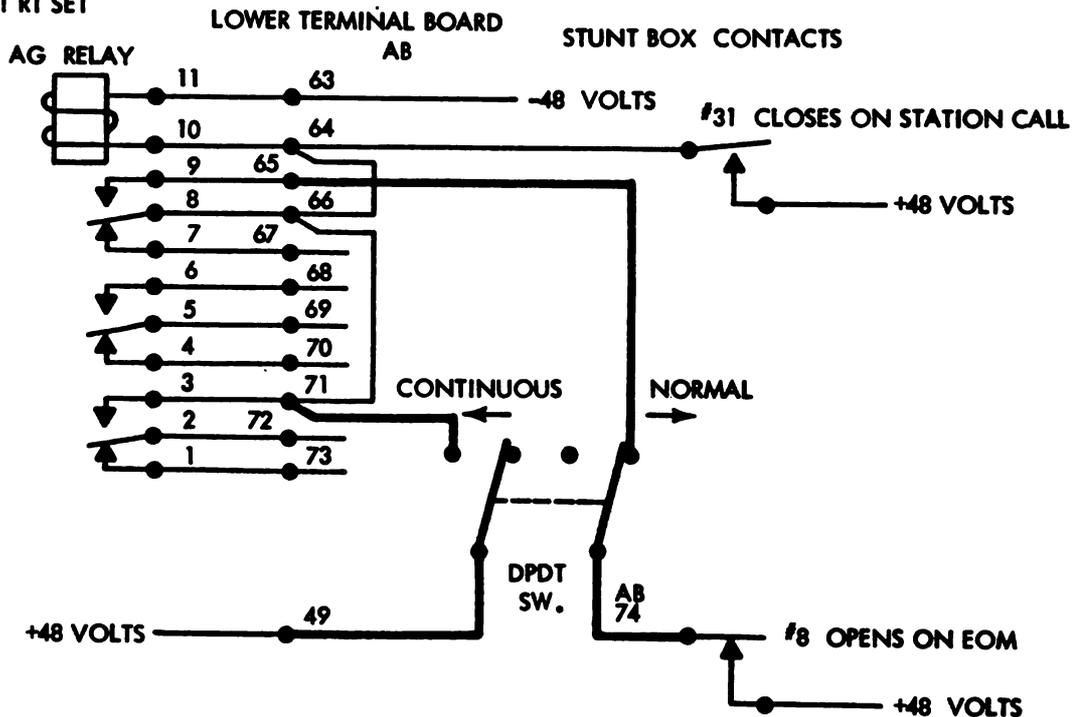
FIG. 1

NOTE: HEAVY LINES INDICATE REQUIRED CHANGE

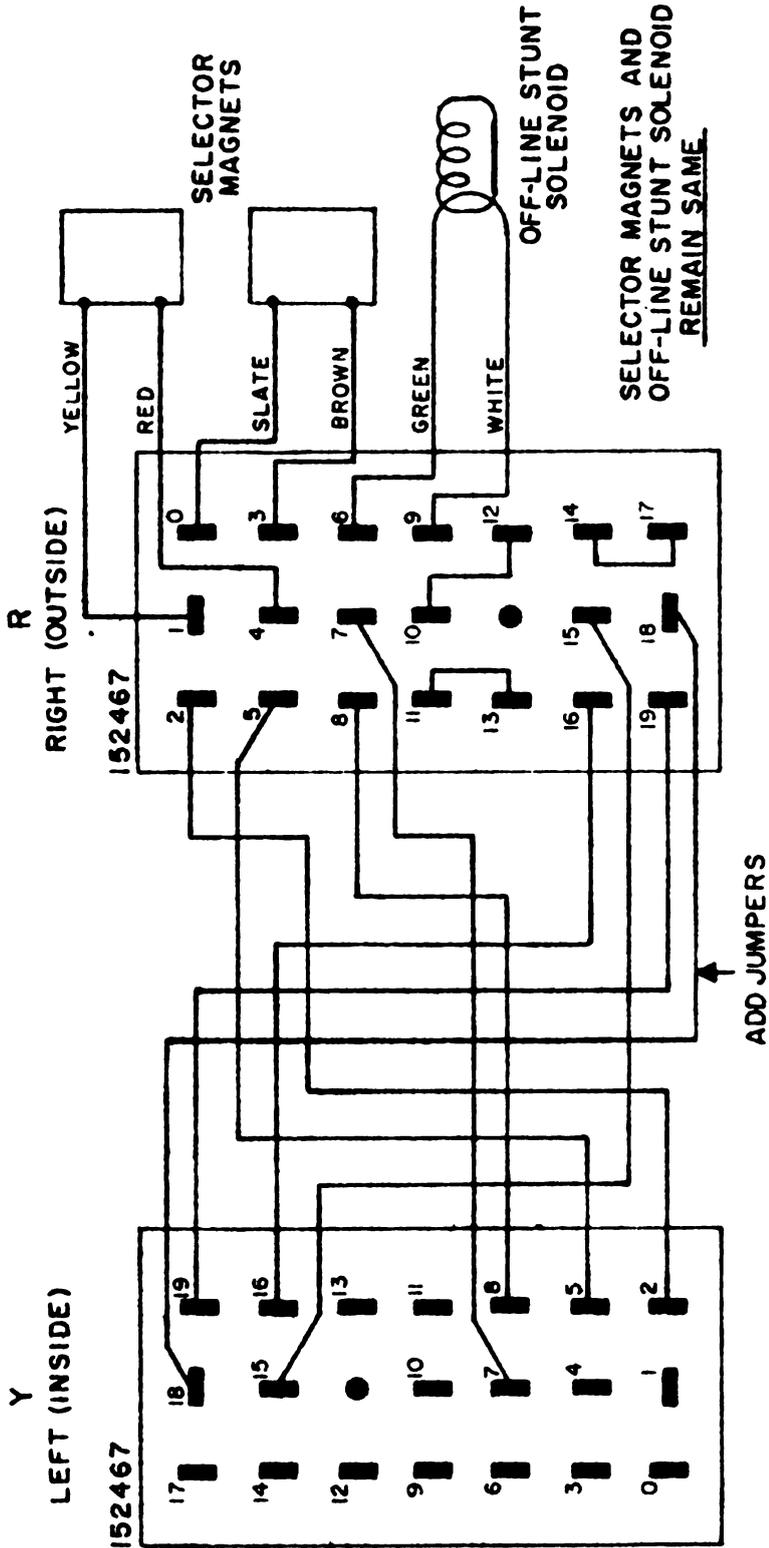
FIGURE 3. STRAPPING BETWEEN CONNECTORS ON TYPING UNIT.

1. LEAVE SELECTOR MAGNET AND STUNT SOLENOID AS WIRED
2. STRAP TERMINALS 18 TO 18, 19 TO 19, 16 TO 16, 15 TO 15, 8 TO 8, 7 TO 7, 2 TO 2, 5 TO 5.

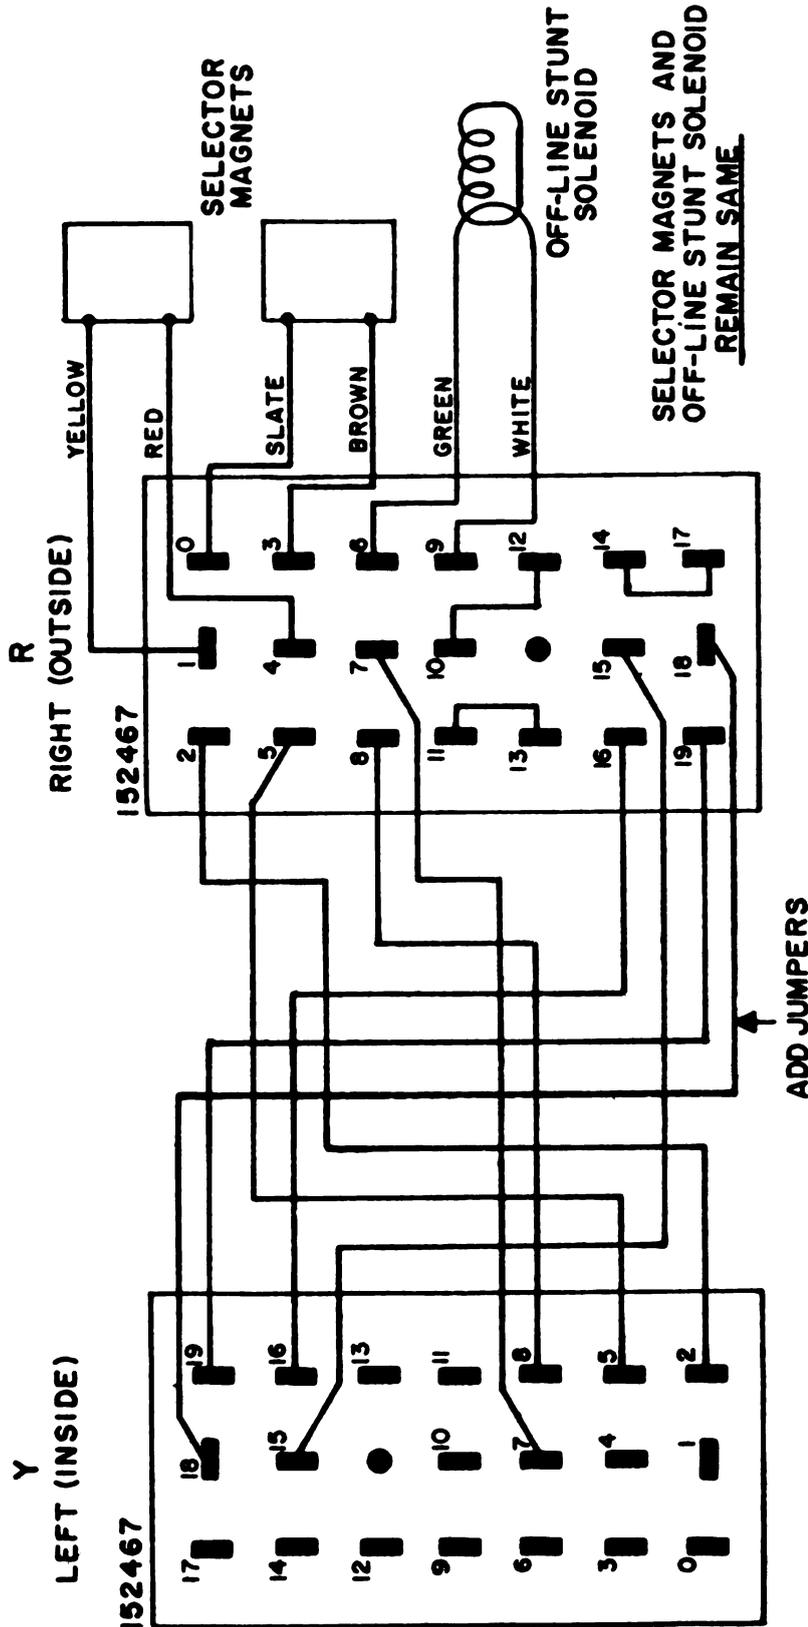
FIGURE 3. STRAPPING BETWEEN CONNECTORS ON TYPING UNIT.

1. LEAVE SELECTOR MAGNET AND STUNT SOLENOID AS WIRED
2. STRAP TERMINALS 18 TO 18, 19 TO 19, 16 TO 16, 15 TO 15, 8 TO 8, 7 TO 7, 2 TO 2, 5 TO 5.
