# HOLLOW STATE NEWSLETTER

*"For lovers of vacuum tube radios"*

**Issue # 48**  
**Summer-Fall 1999**

## **TAMING POWER-ON CURRENT SURGE**

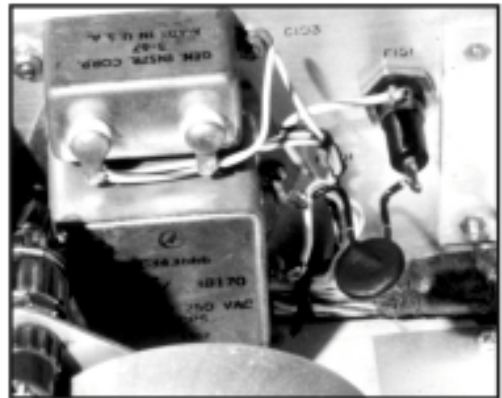
Installing an in-rush limiter in the R-390A is very simple. There is a short wire that connects the centre lug on fuseholder F101 to the top lug (closest to the C103 bathtub capacitor) on the FL101 AC line filter mounted on the rear apron. At least this seems to be the usual configuration, but I do have one EAC chassis that connects this wire to the other FL101 lug. It doesn't matter, just be sure that your line cord is wired so that the in-rush limiter is in the hot lead between F101 and FL101.

Remove this wire and replace with the CL-80 current in-rush limiter. There is quite a lot of space here, so the device can be mounted well clear of surrounding components. Don't just tack the leads to the lugs, but make a solid physical connection so that the limiter will stay exactly where you install it!

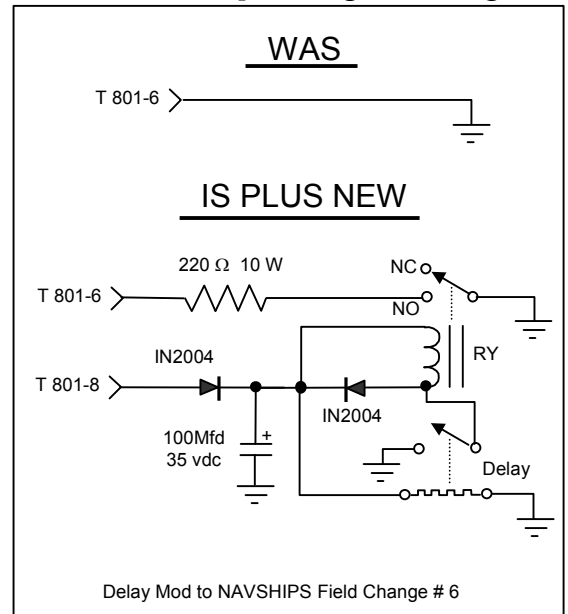
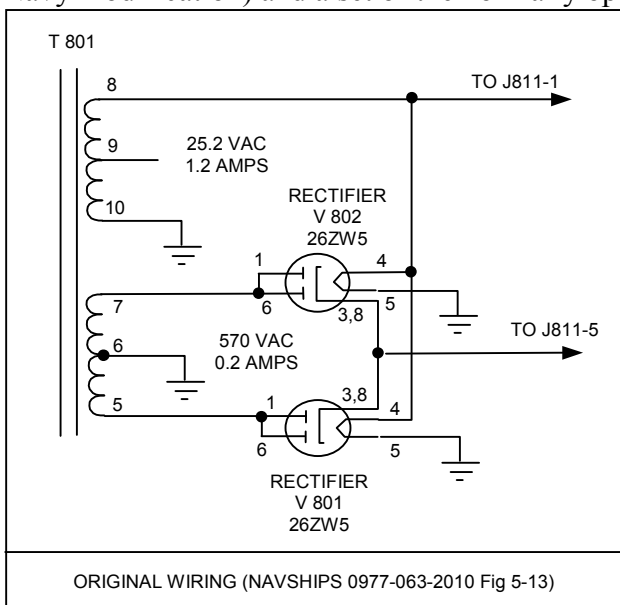
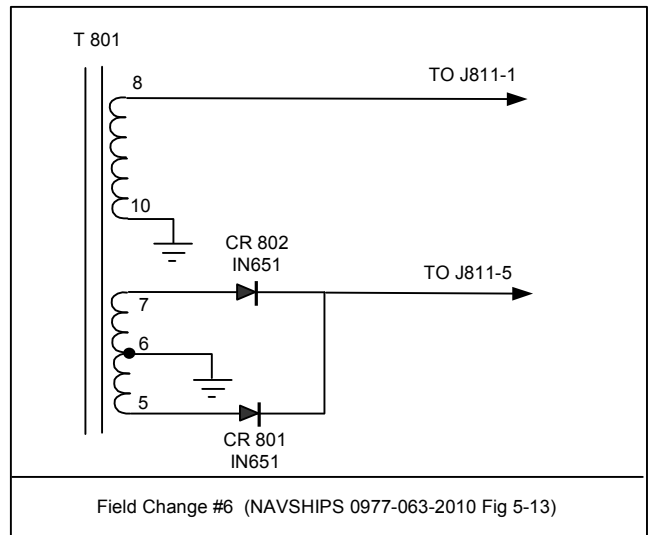
The power supply module is available from several sources in case you want to keep one intact for the ‘original’ configuration. There are several ways to approach this, I chose one that was dictated by the parts that were in my junk collection, yet I wanted it to look good and to achieve the expected end result. My unit already had the Navy HV rectifier modification which can be found elsewhere. *[The original wiring and the HV rectifier mod are shown near the end of this article – Ed.]*

The next item was a Allied Control MHX-4043 sealed power relay, again the choice was dictated by what I had on hand that would fit and could be powered by the 25 VDC that I was using for the time delay relay. A diode across the relay coil to de-spoke was added. The center tap of the 570 volt winding was disconnected and the path was replaced with a 220 ohm power resistor (to approximate the internal resistance of the rectifier tubes, something that should have been done with the Navy modification) and a set of the normally open contacts on the Allied relay. A bracket was required to hold and heat sink the 220 ohm resistor.
